COMMON REINFORCED CONCRETE BUILDING CONSTRUCTION DEFICIENCIES IN AFGHANISTAN AND RECOMMENDATIONS- A REVIEW ARTICLE

Mojeeburahman Mashal¹

¹Structural and Earthquake Engineering, Lecturer, Kabul Polytechnic University, Kabul, Afghanistan

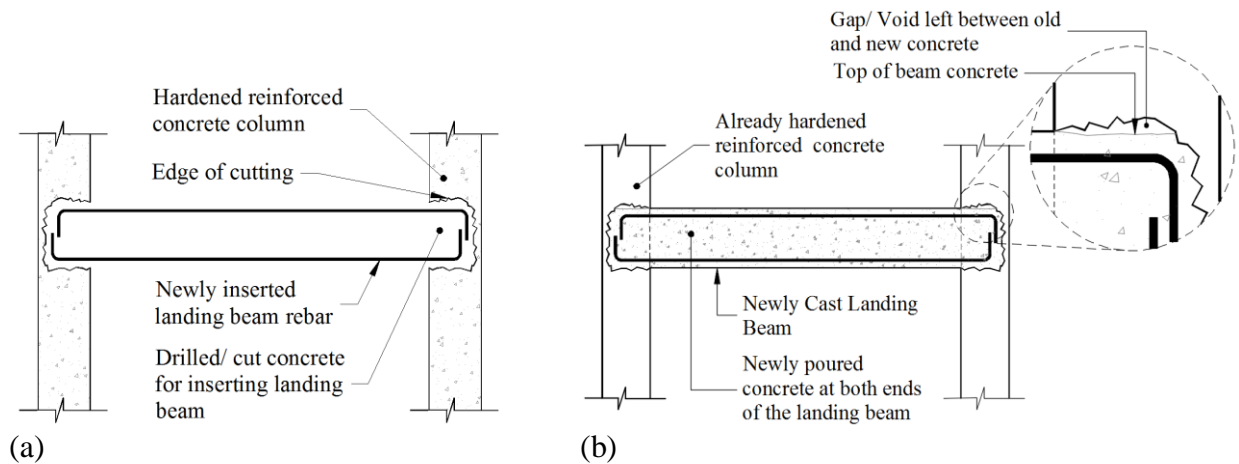
Figure 1 Deficiency Type I (a) Hardened column is drilled/cut and landing beam longitudinal reinforcement inserted. (b) Landing beam concrete is poured, a Gap/ Void is created due to concrete setting, concave up drilling/ cutting and concrete shrinkage.

1. It is most likely that the newly added landing beam longitudinal reinforcement may not develop sufficiently at its both ends due to confined space after drilling/ cutting of the column.

2. Most likely a Gap/ Void (see enlarged part of Figure 1 (b)) is created at both ends of newly inserted landing beam after pouring its concrete due to concrete setting, possible concave up drilling/ cutting and concrete shrinkage. This gap has considerable negative impact on the performance of beam-column joint:

- a. The gap results in absence or lack of bond between already hardened column concrete and the newly poured beam concrete. This lack of bond substantially reduce (since essentially the cross-sectional area of column is greatly reduced) flexural and axial capacity of the column.

- b. The gap may lead to compressive yielding of column reinforcement due to lack of concrete to support axial load of the column. Yielding of column rebar may lead to creation of a plastic hinge at the joint.

1. Cutting/ drilling of already constructed structural member should be avoided at all. This can be done by proper detailing and follow of the construction plans of the building and frequent inspection of the construction activities by qualified engineers.

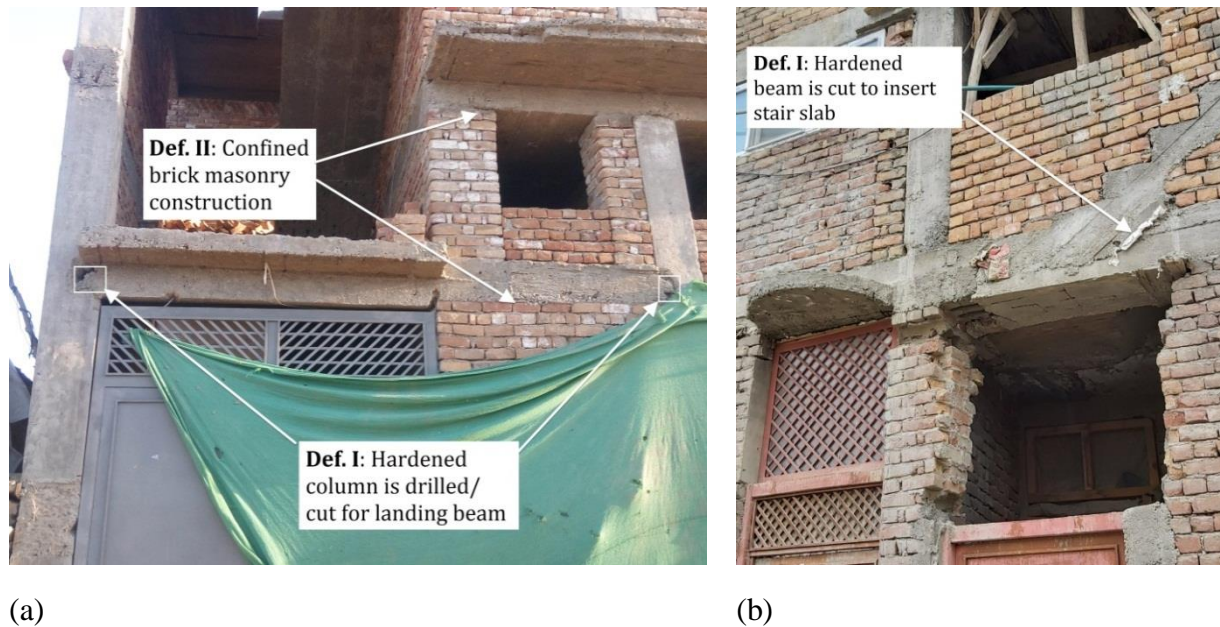
Photo 1 (a) Hardened column in a five story residential building is drilled/ cut and landing beam inserted (Photo from Mr. Naeem Sorosh, 2018). (b) Hardened beam is cut/ drilled at a four story residential building and stair slab is inserted (Photo by the author, 2020)

Drilling/ cutting of hardened concrete to add new member is a common construction deficiency shared among many newly constructed buildings in Afghanistan. Buildings with such deficiency are highly vulnerable especially during extreme loading events such earthquakes.

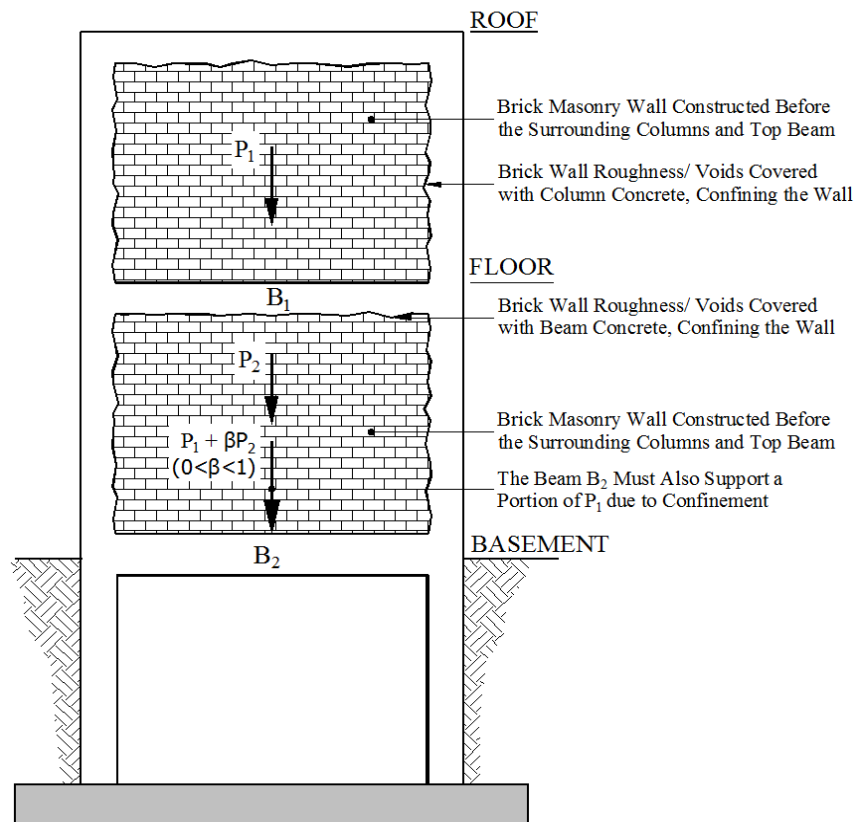
Figure 2 Deficiency Type II: Unintentional confining of the infill walls that is not accounted for in the analysis and design of the structure.

3. In fairly moderate number of cases, it happened that infill walls were confined in one or more upper floor(s) while not confined or no walls located at all at a lower floor. This scenario results in transfer of large amount of gravity loads from the upper floors to the beams in lower floor due to relatively lesser rigidity of the beams compared to that of walls. This again overstresses the lower beams as the actual scenario was not accounted for in the analysis and design of the building. As per 12.4 of ASCE 7^[2], the loads further increases due to the effects of vertical component of earthquake loads. This is depicted in Figure 2 above.

2. Masonry infill wall that are not bearing type in nature shall not be confined. For this, building framing in a story under construction must be completed first followed by construction of infill walls. A mechanism shall be provided to allow free deflection of flexural members.

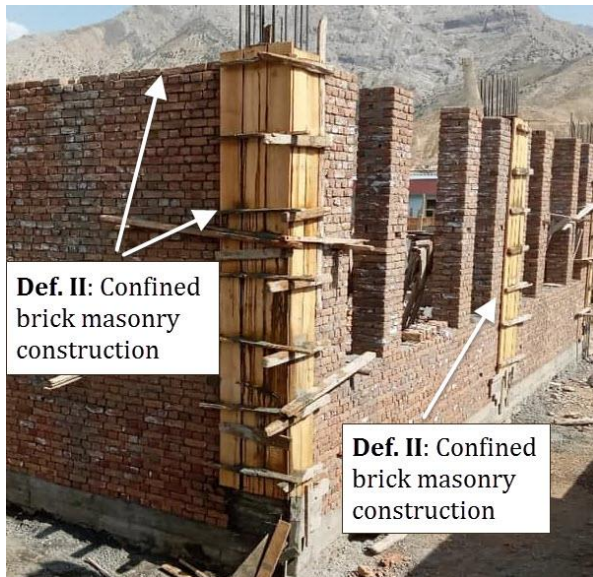
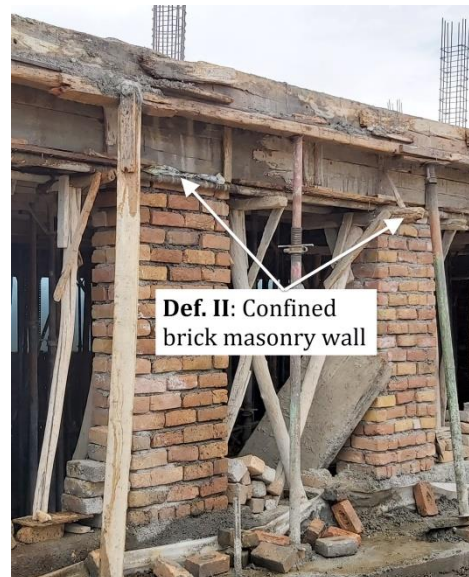
Photo 2 (a) Confining brick masonry walls (by columns and beams) in a school building (Photo from:

<https://www.facebook.com/MUDLAFG/photos/a.157128744449109/1539201206241849/?type=3&theater>). (b) Confining brick masonry wall by beam (Photo by the author, 2020)

1. Confining infill walls in most cases modifies stiffness distribution of the building due to inappropriate/ unsymmetrical locations of confined infill walls. Stiffness modification results in redistribution of forces in the structure leading many times to overstressing of members that were barely adequate for resisting the loads before stiffness modification (i.e. when the infill walls are not confined).

2. Confining infill walls changes center of rigidity of the structure and hence results in larger eccentricity and ultimately increased torsional irregularity. This increased torsional irregularity that was not accounted for during analysis and design (i.e. it was designed as moment resisting frame where infill are considered not be confined) further stresses structural elements.

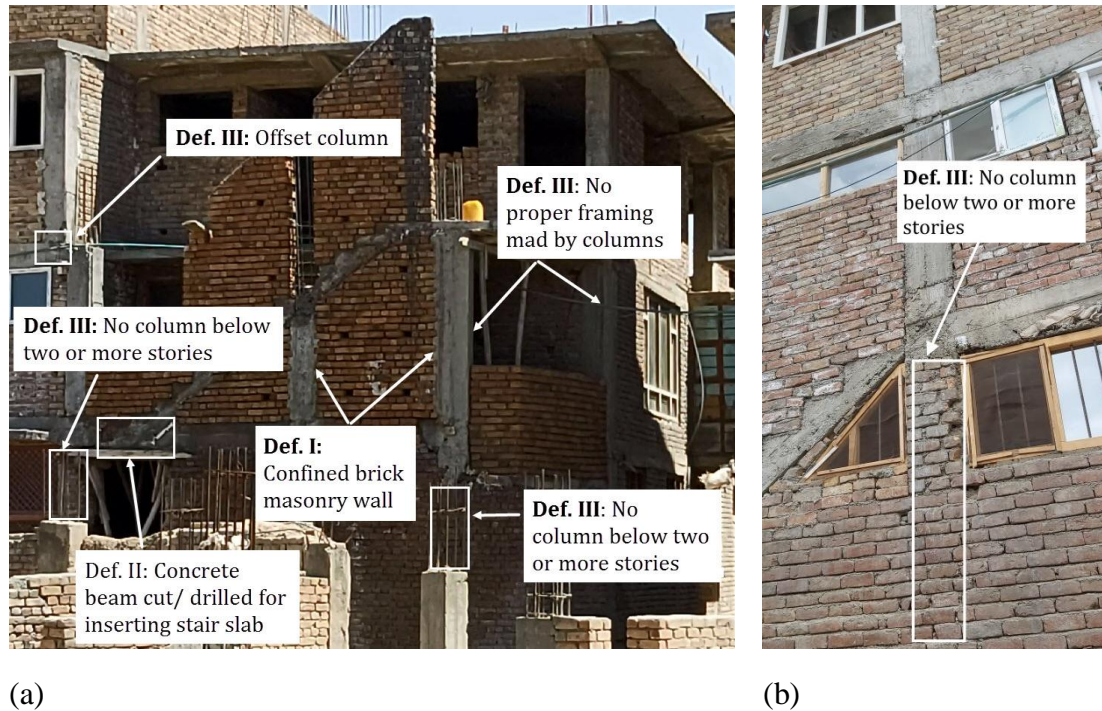
In many other instances, reinforced concrete buildings were constructed such that no complete and appropriate frame over the height of the structure could result. Columns were removed in a lower floor for any reason but provided in upper floor(s) that again in addition to increasing torsional irregularity results in creation of a soft story mechanism. Soft story buildings are extremely susceptible to earthquake induced damage and even collapse ^[7]. See Photo 3 below.

Photo 3 (a) Multiple construction deficiencies in a four (or more) story reinforced concrete building (Photo by the author, 2019). (b) Deficiency type III, column at a lower story is removed (Photo by the author, 2019)

3. Columns offset should be avoided unless properly accounted for it in the design. A complete building frame (without removal of columns in any story or without columns deviation that is not accounted for) is needed to anticipate satisfactory performance of the building during earthquakes or other later loadings.
